Re: After-the-fact applications for unpermitted bulkhead--PSJ000-12-0019,
PSJXMP-15-0028

Friends of the San Juans ("Friends") submits this letter and the attached materials to address a request by Whaleback LLC for after-the-fact approval of an unpermitted rock bulkhead built in January 2011 on the southeastern shores of Blakely Island, along tax parcels no. 151024002 and 151024003 ("Property"). The San Juan County Department of Community Development ("DCD") file for the project includes applications for both an exemption and a permit for the bulkhead. Both applications rely on the same consultant reports, so this letter refers to them both as the Application.

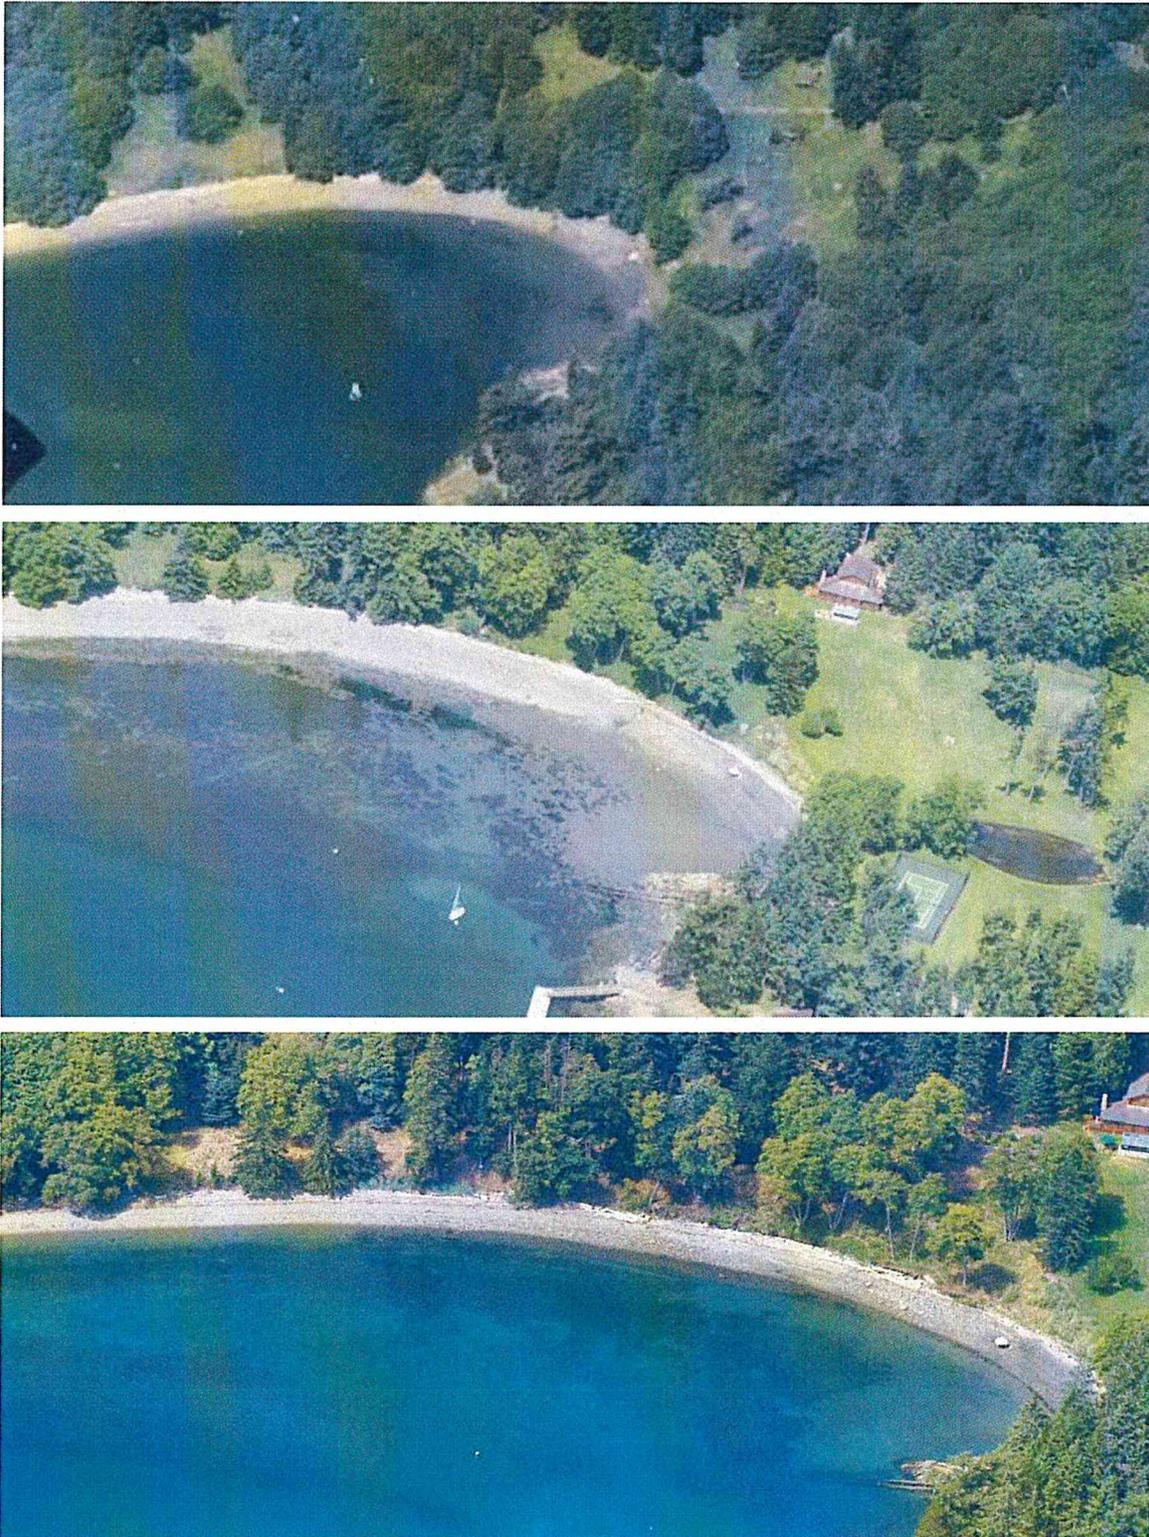
Figure 1. Shoreline oblique aerial photos by the WA Dept. of Ecology: June 1977 (top), June 2002 (middle), and August 2006 (bottom)

The erosion of the bank toe appears as if it may have coincided with work to develop this site. Specifically, this erosion appears to have been associated with clearing and constructing/enlarging the access road and utilities leading southwestward to the house. A significant amount of clearing and a temporary roadway is evident waterward of the full length of the house in 2011 (Figure 2), which may have extended to very near the top of bank. It appears that this amount of clearing relatively close to a marine bank without drainage control could have caused what appears to have been several very small and shallow surficial slides. As shown in the 2006 aerial photo (Figure 1), the uplands were almost completely forested.

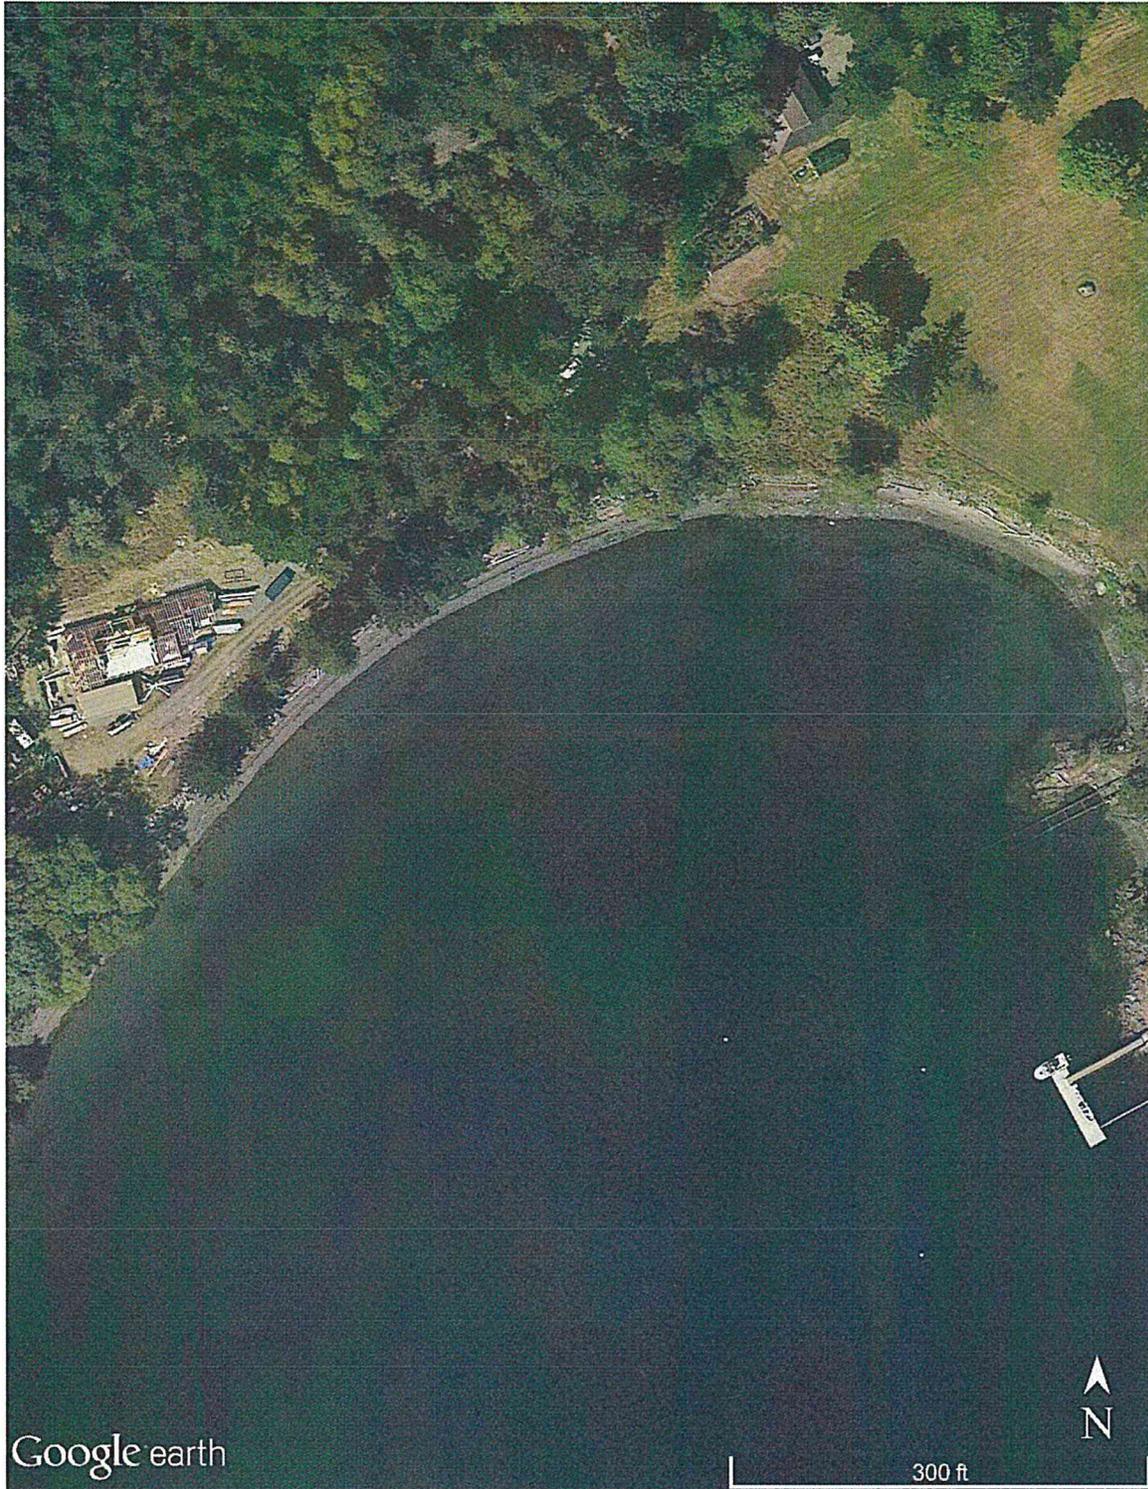
Figure 2. Vertical aerial photo from August 2011.

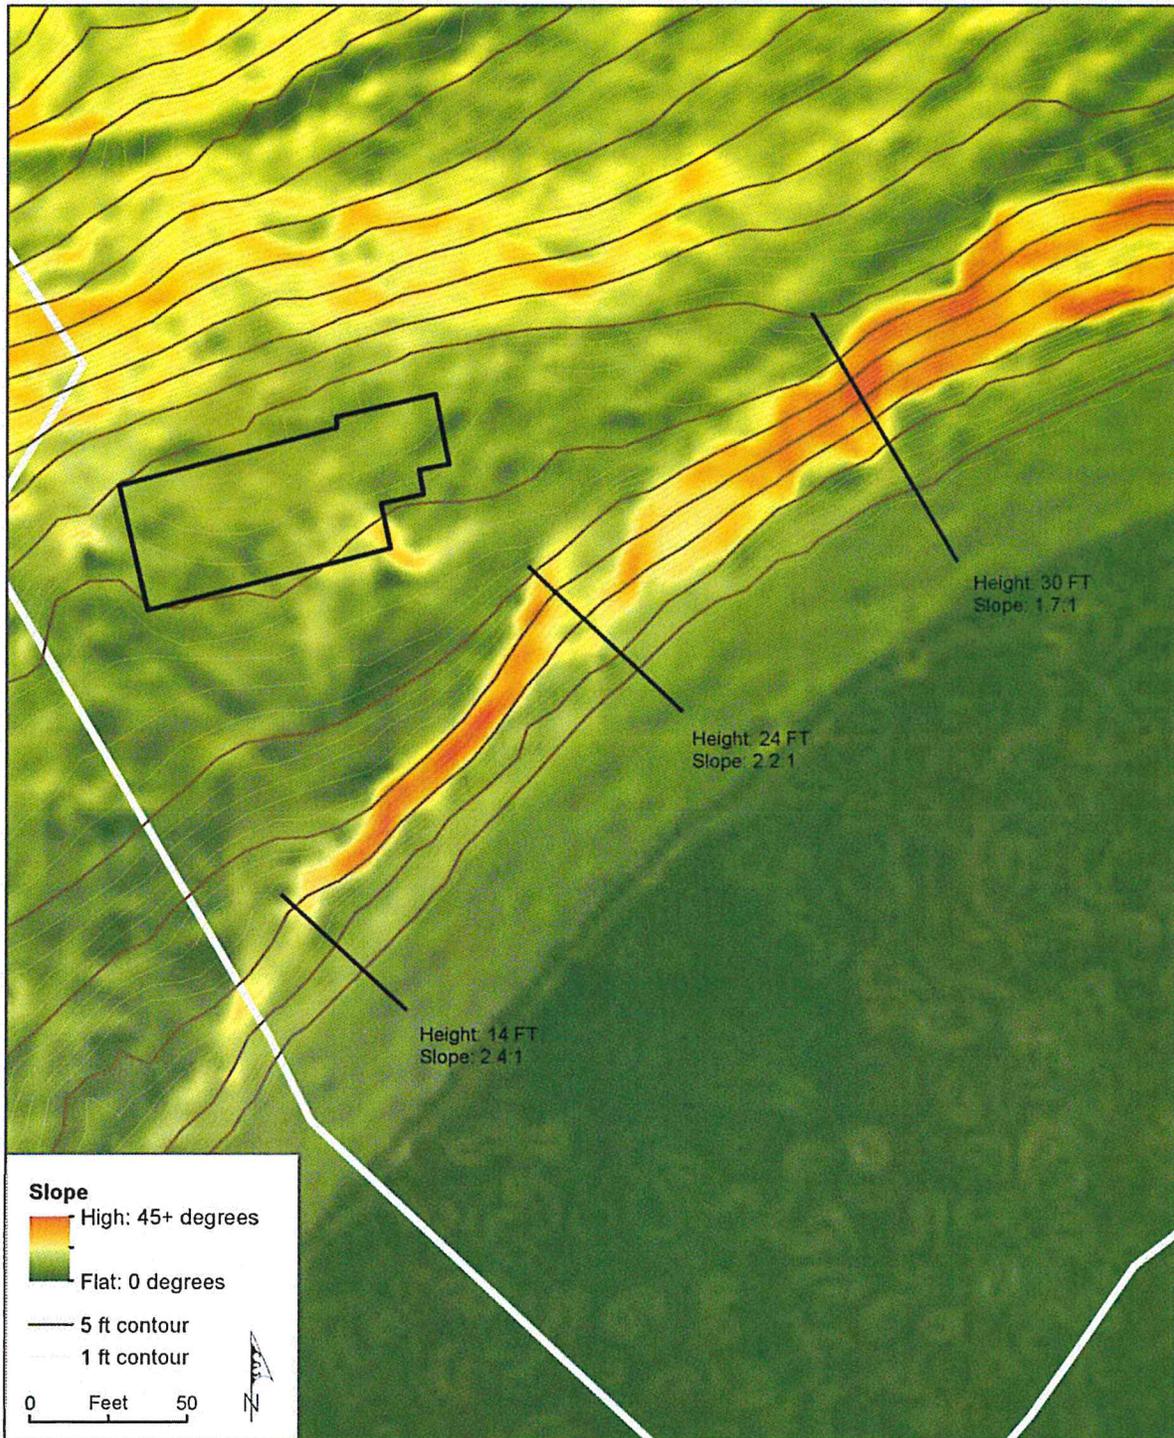
Figure 3. Topography at the subject property derived from LiDAR data (San Juan County 2013).

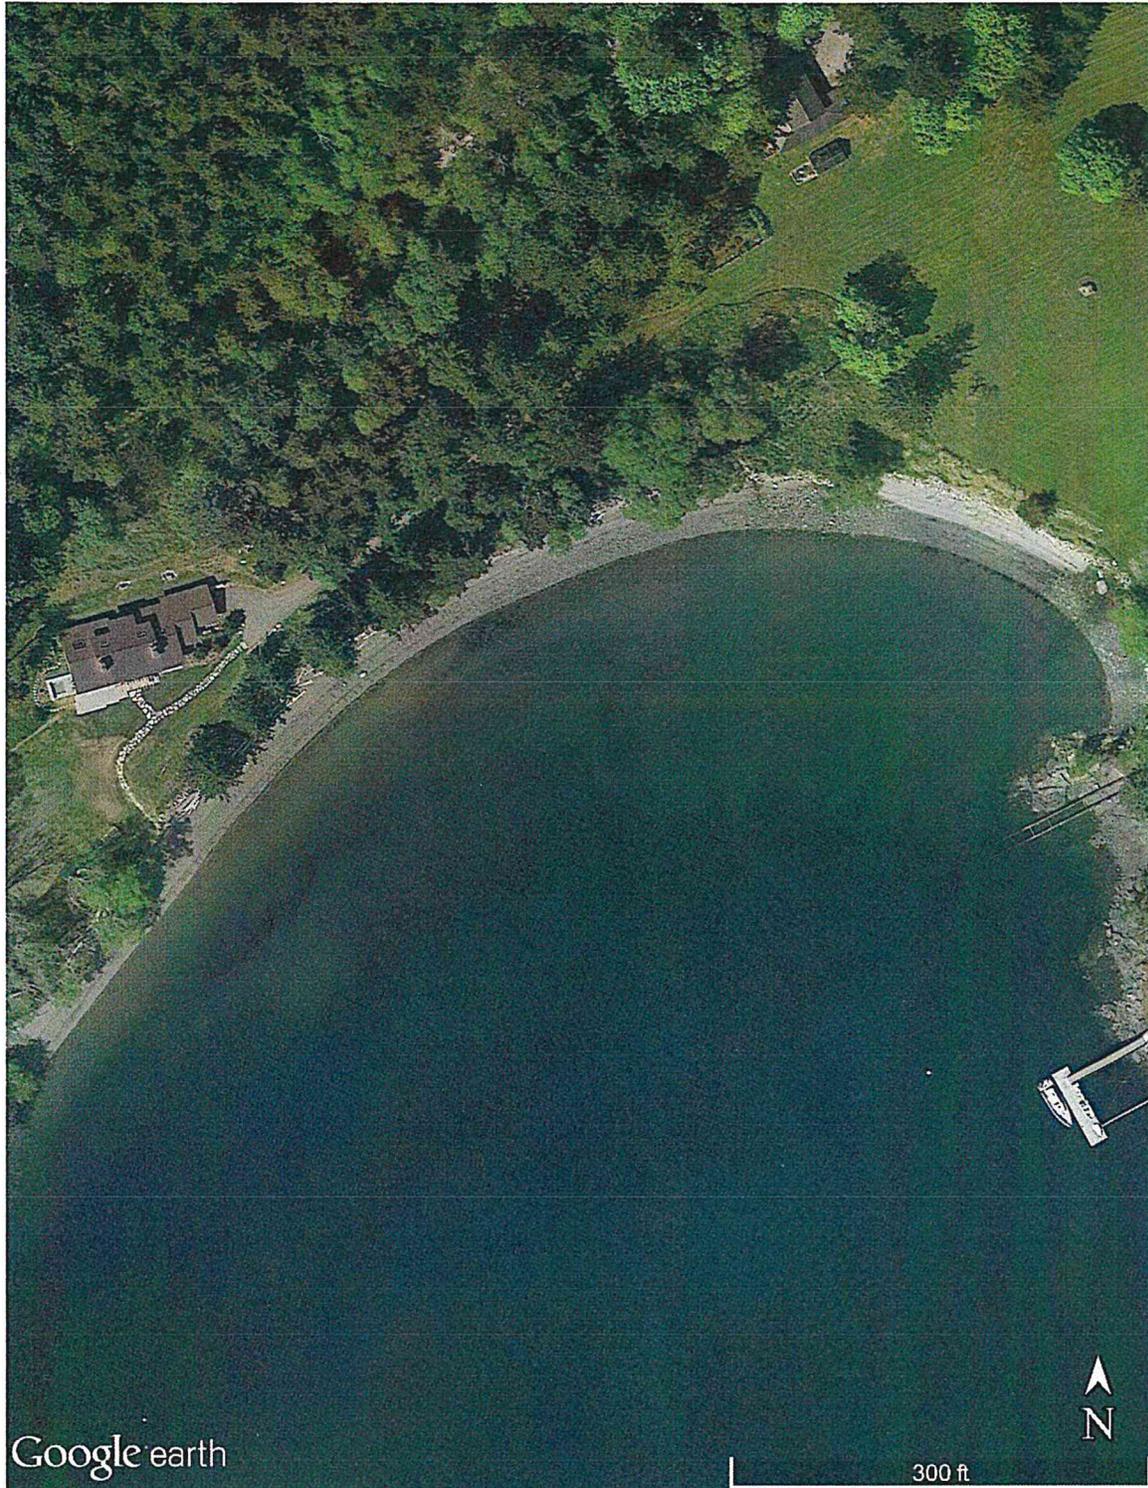
Figure 4. Vertical aerial photo from May 2015.

Figure 4. Vertical aerial photo from May 2015, provided through Google Earth.

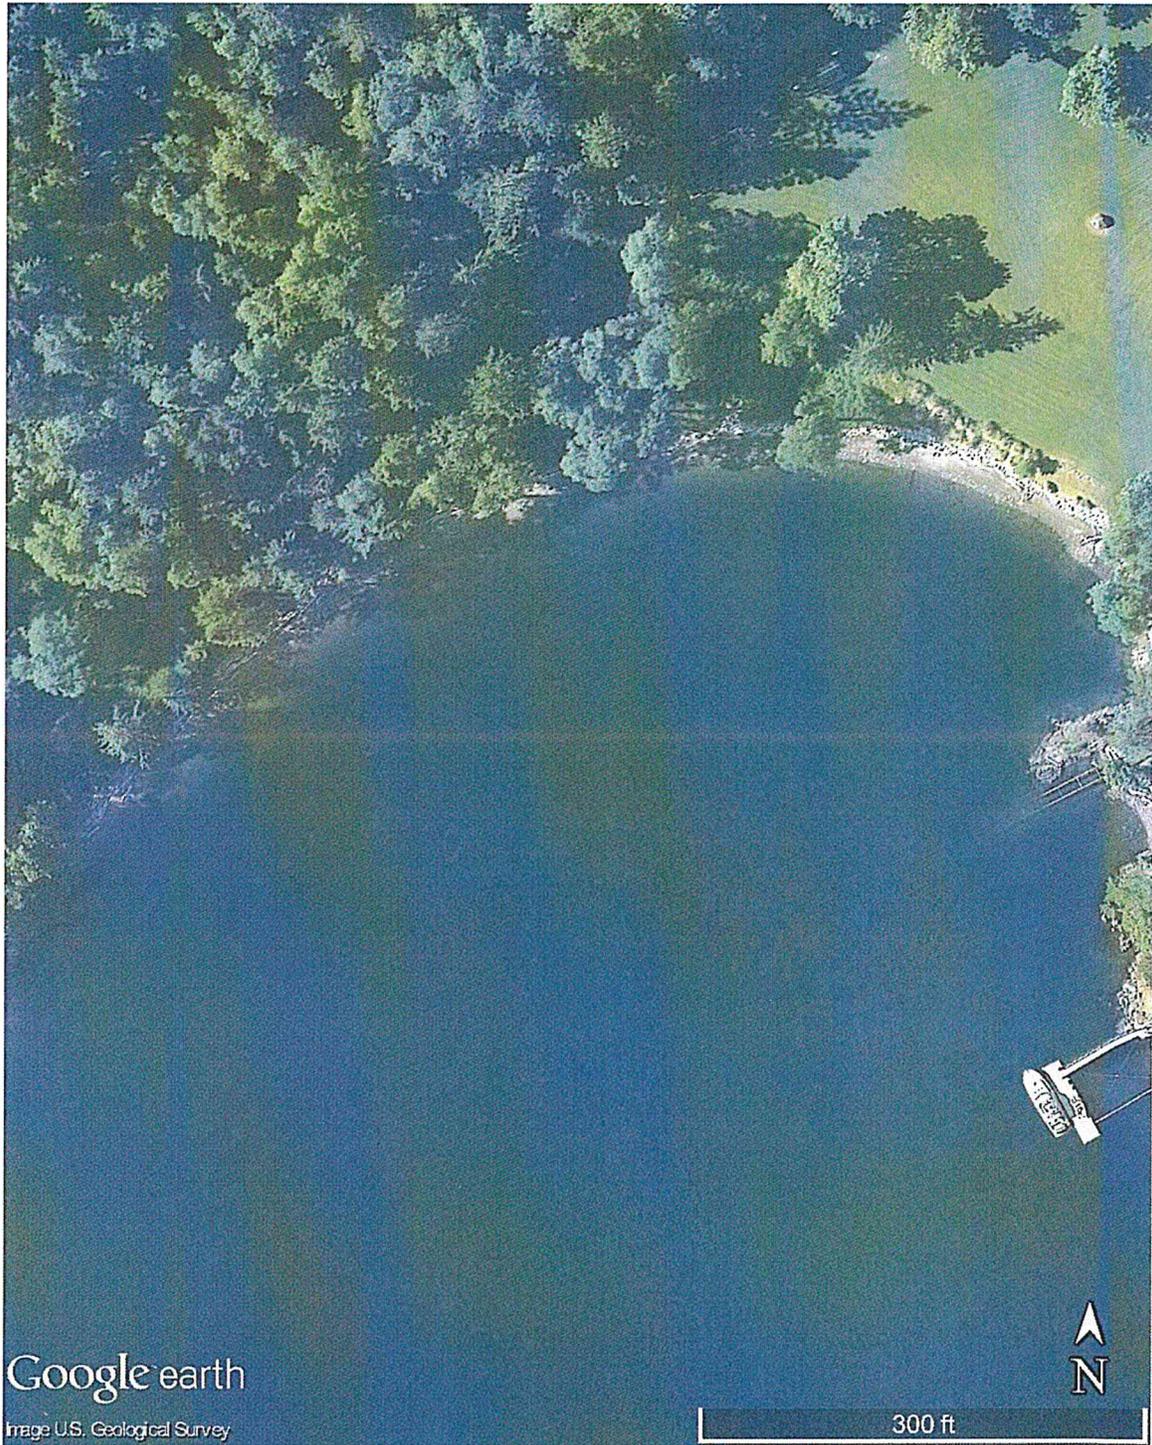
Figure 5. Vertical aerial photo from June 2008.

Figure 5. Vertical aerial photo from June 2008, provided through Google Earth.

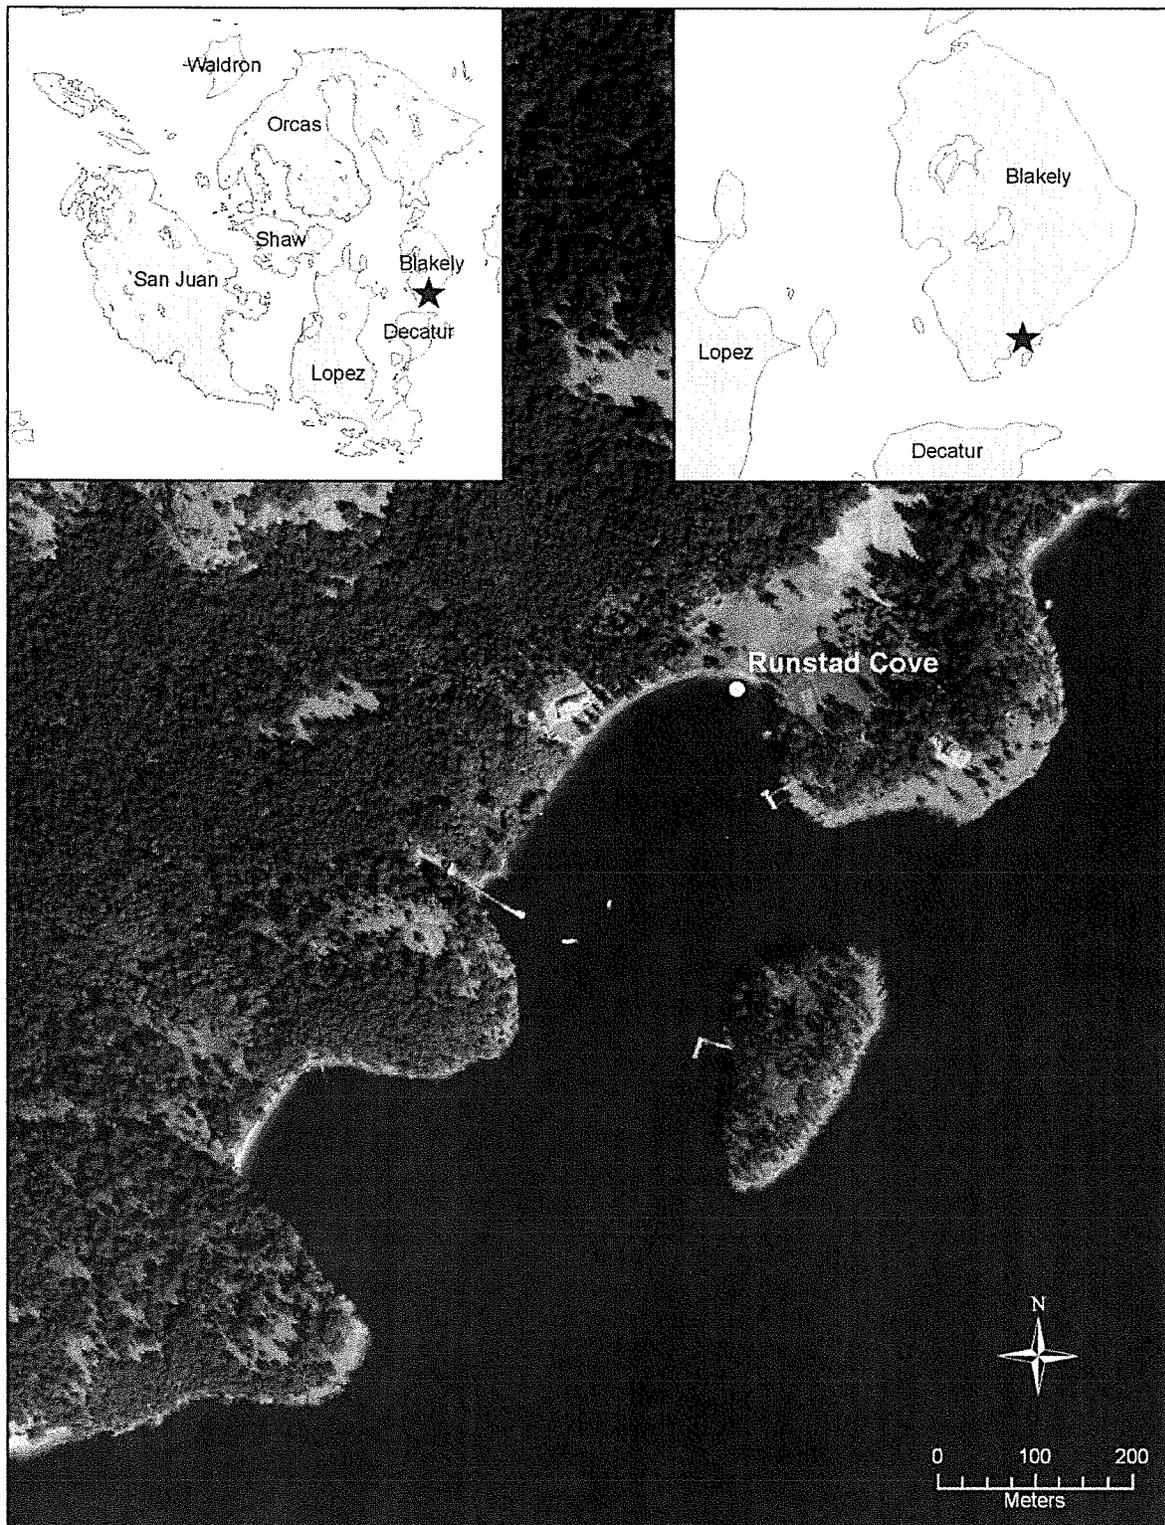
Figure 1. Location of Runstad Cove beach seine site.
