September 2, 2015
Job No. 15-0018

**Re: Geological Review of the Stormwater Site Plan (SSP)
Proposed Rosario Resort Expansion
1400 Rosario Road & 3231 Olga Road
Eastsound, WA 98245
TPN 160621001000 & 173043001000**

Attachment: Hart Pacific Engineering's, Stormwater Site Plans, Figures 6.1 to 6.6
ASFE - Report Limitations and Guidelines for Its Use (3 pages)

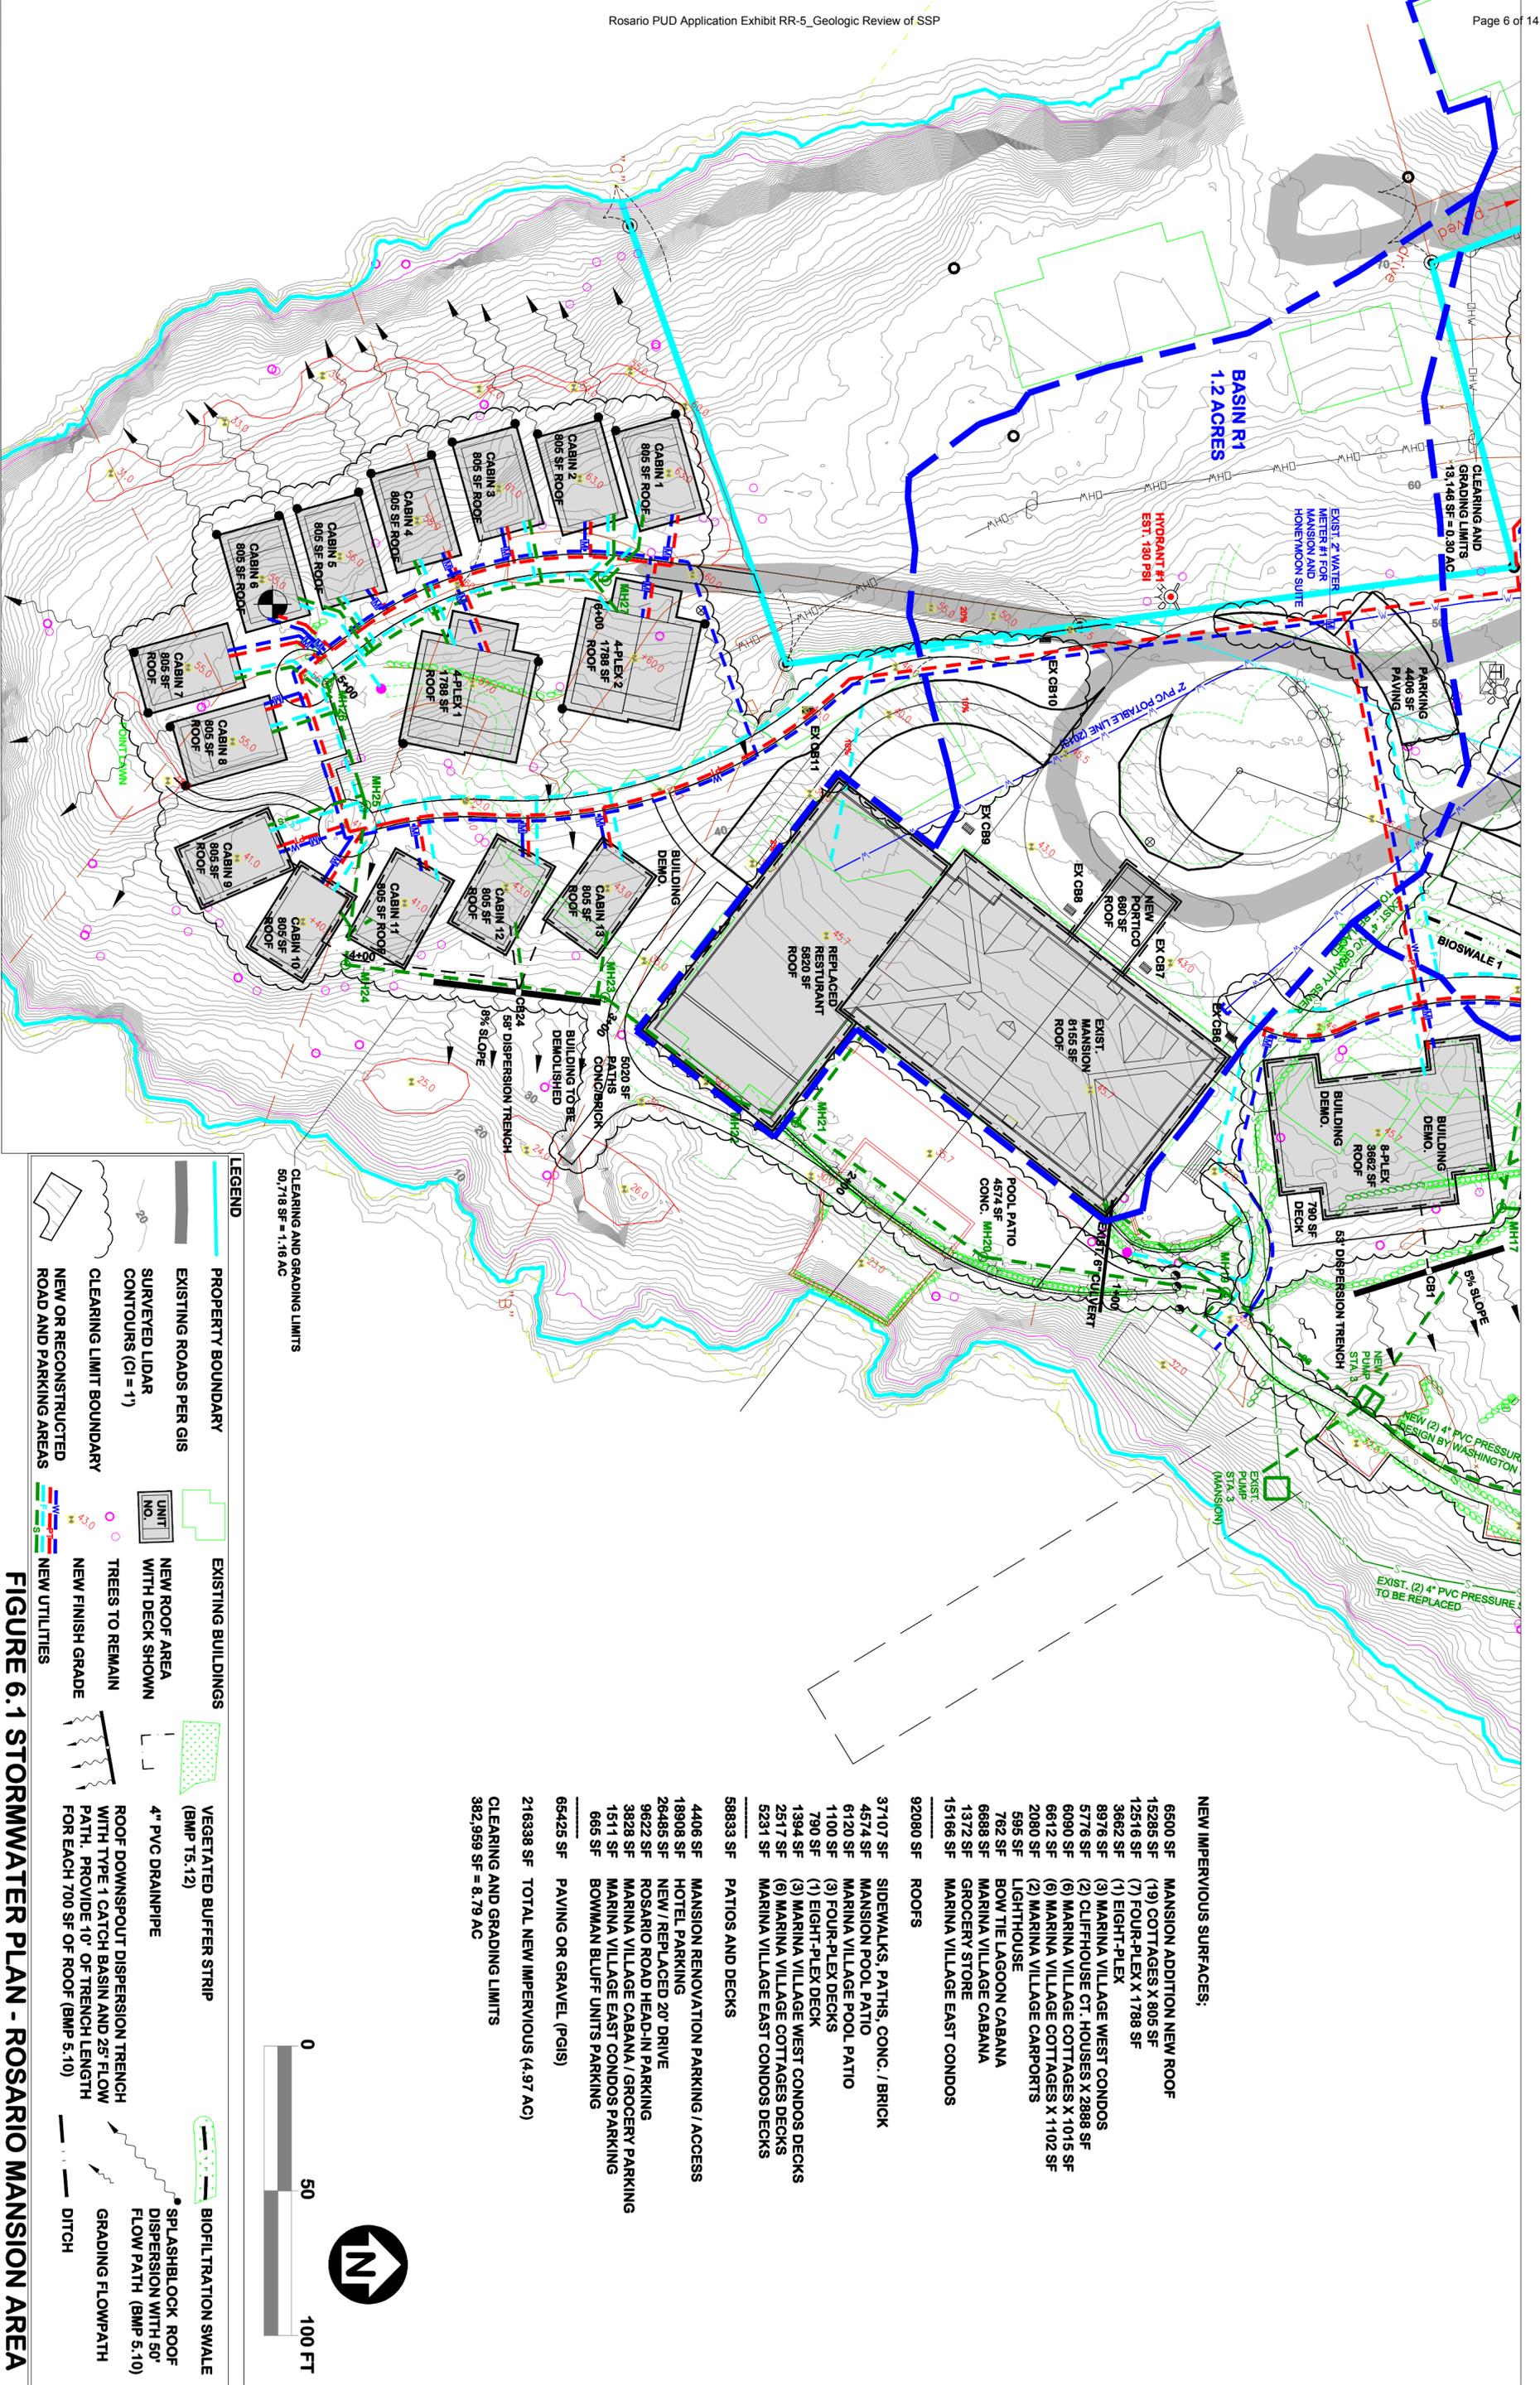
FIGURE 6.1 STORMWATER PLAN - ROSARIO MANSION AREA

NEW IMPERVIOUS SURFACES:

- 6500 SF MANSION ADDITION NEW ROOF
- 15285 SF (19) COTTAGES X 805 SF
- 12516 SF (7) FOUR-PLEX X 1788 SF
- 3862 SF (1) EIGHT-PLEX
- 8976 SF (3) MARINA VILLAGE WEST CONDOS

- 4406 SF MANSION RENOVATION PARKING / ACCESS
- 18908 SF HOTEL PARKING
- 26485 SF NEW / REPLACED 20' DRIVE
- 9622 SF ROSARIO ROAD HEAD-IN PARKING
- 3828 SF MARINA VILLAGE CABANA / GROCERY PARKING

- CLEARING AND GRADING LIMITS
- 382,959 SF = 8.79 AC
