# CRITICAL AREAS SUMMARY REPORT For Rosario Resort and Spa Redevelopment 2015 Orcas Island, Washington

**CRITICAL AREAS SUMMARY REPORT  
For Rosario Resort and Spa Redevelopment 2015  
Orcas Island, Washington**

**June 17, 2015**

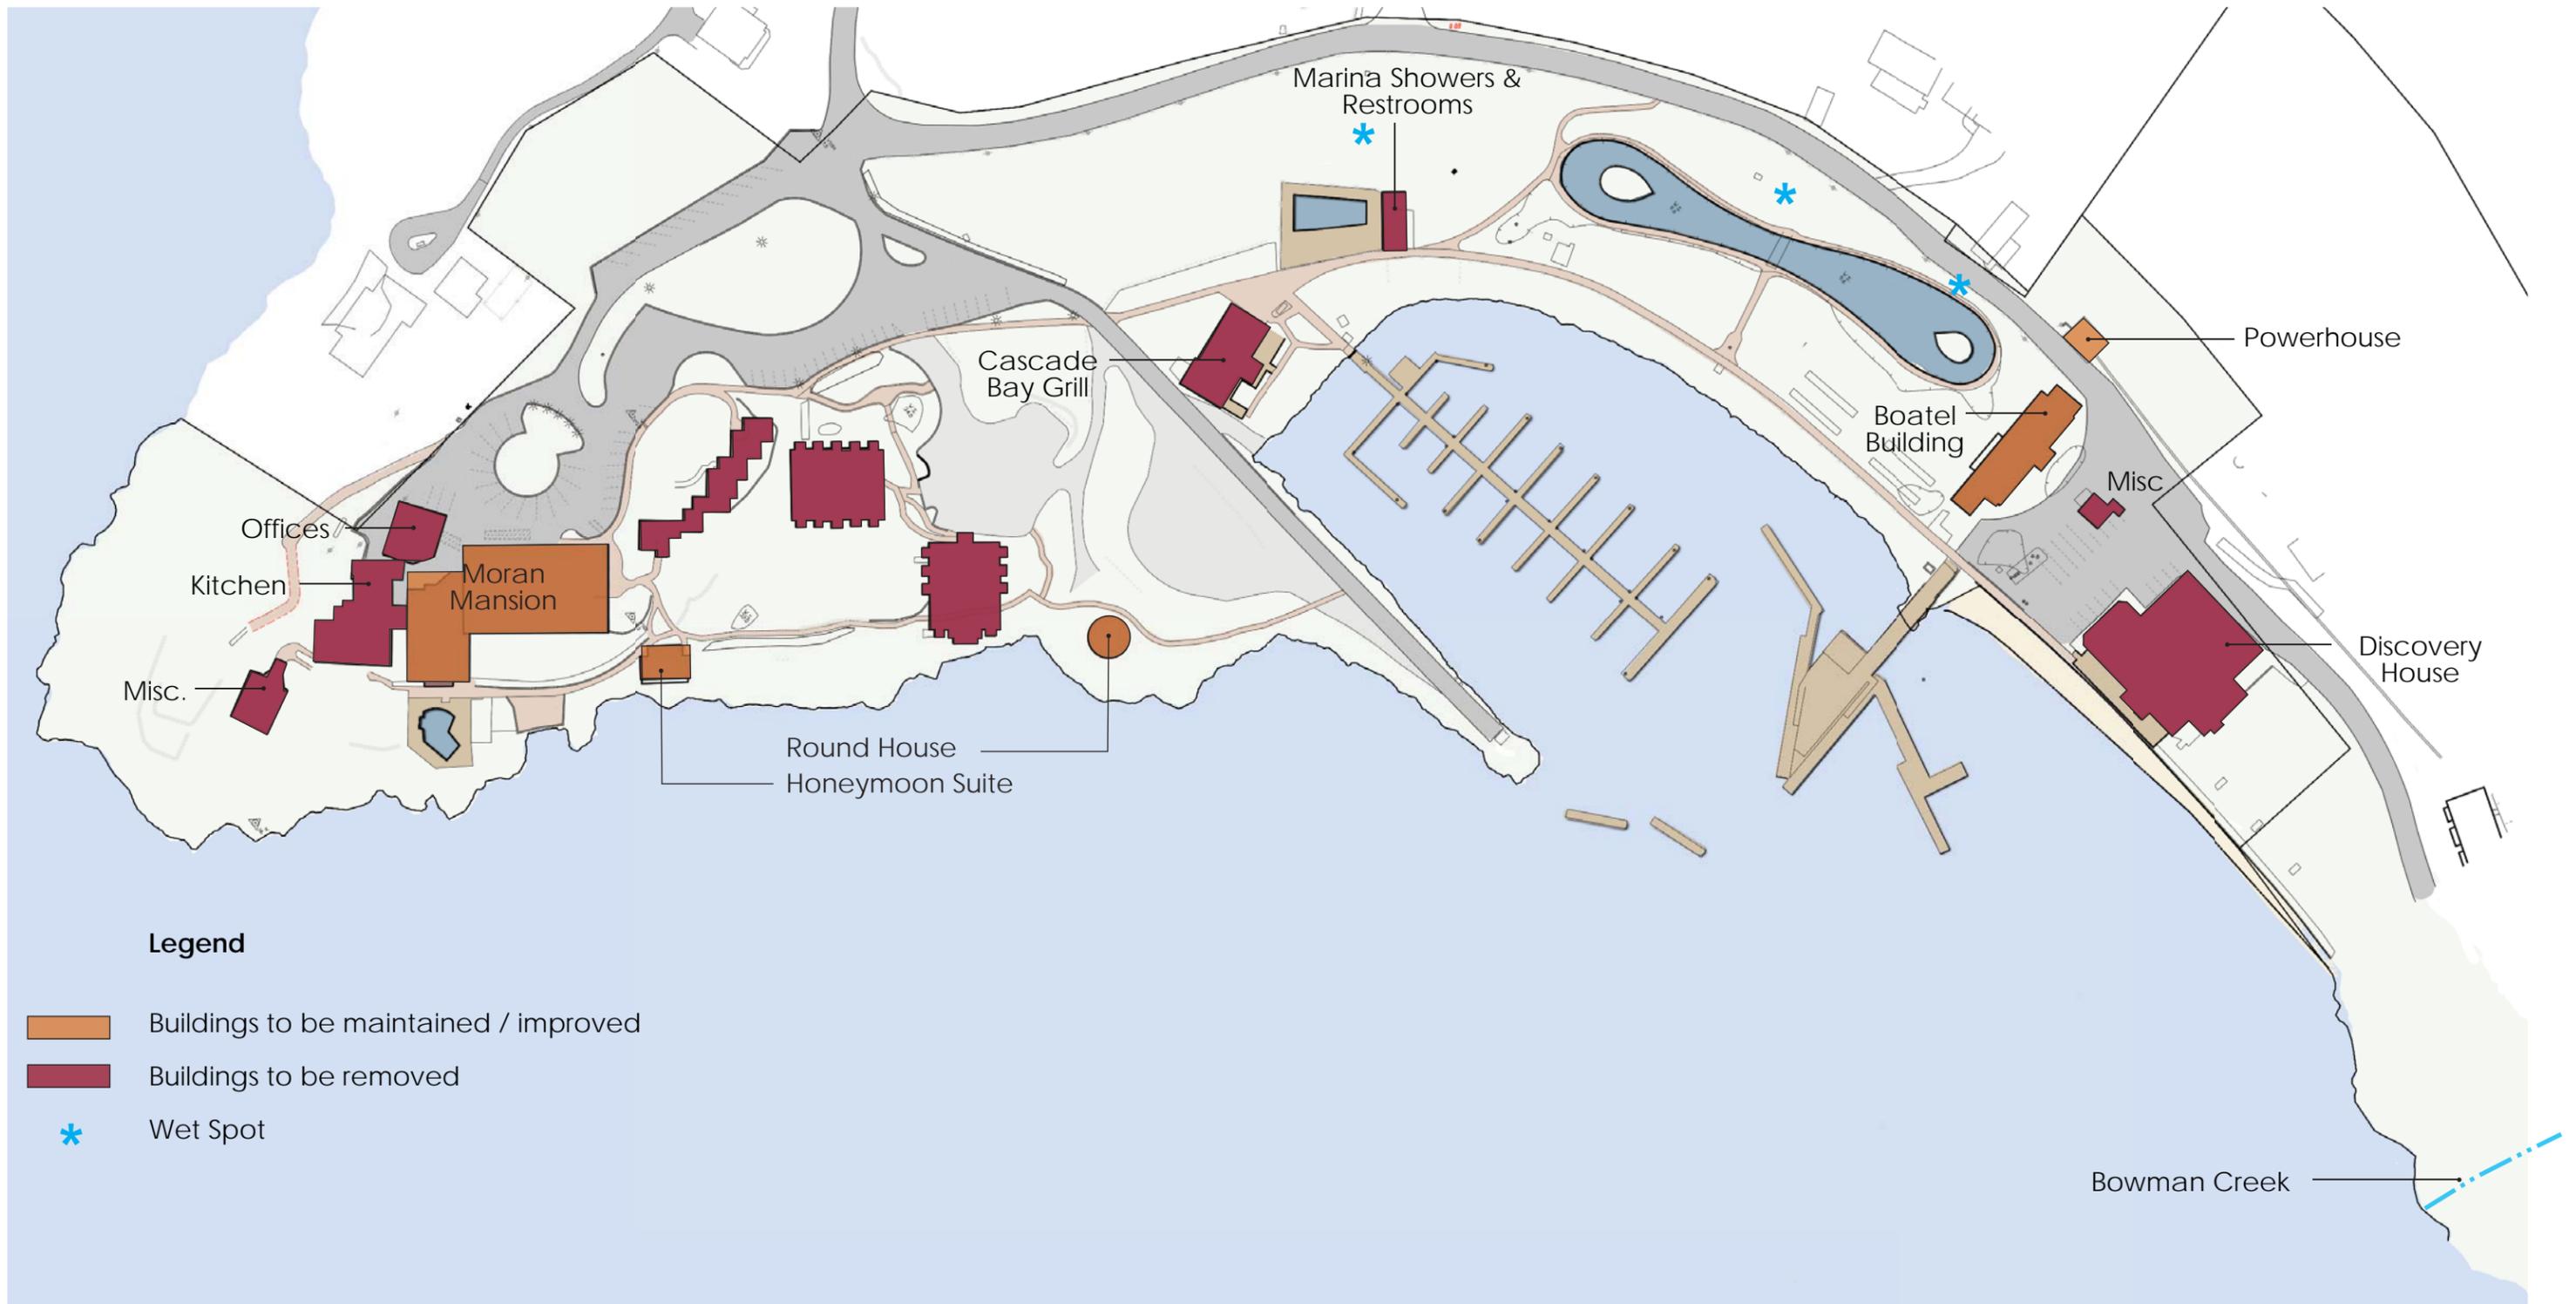
- Buildings to be maintained / improved
- Buildings to be removed
- \* Wet Spot

The redevelopment plan for the Resort Core area includes the removal of three of the five hotel buildings containing a total of 42 units, removal of the conference center building, the boatel and the bar and grill building. The entire Resort Core will be redeveloped with new hotel and vacation units, a new two-story cabana building at approximately the same location previously occupied by the Boatel structure, new and renovated roadways, parking areas and pedestrian paths and new landscaping and will include approximately 6.6 acres of community open space. The Resort Core area is shown in Figure 1 “Existing Area Plan” (GCH Sheet 65).

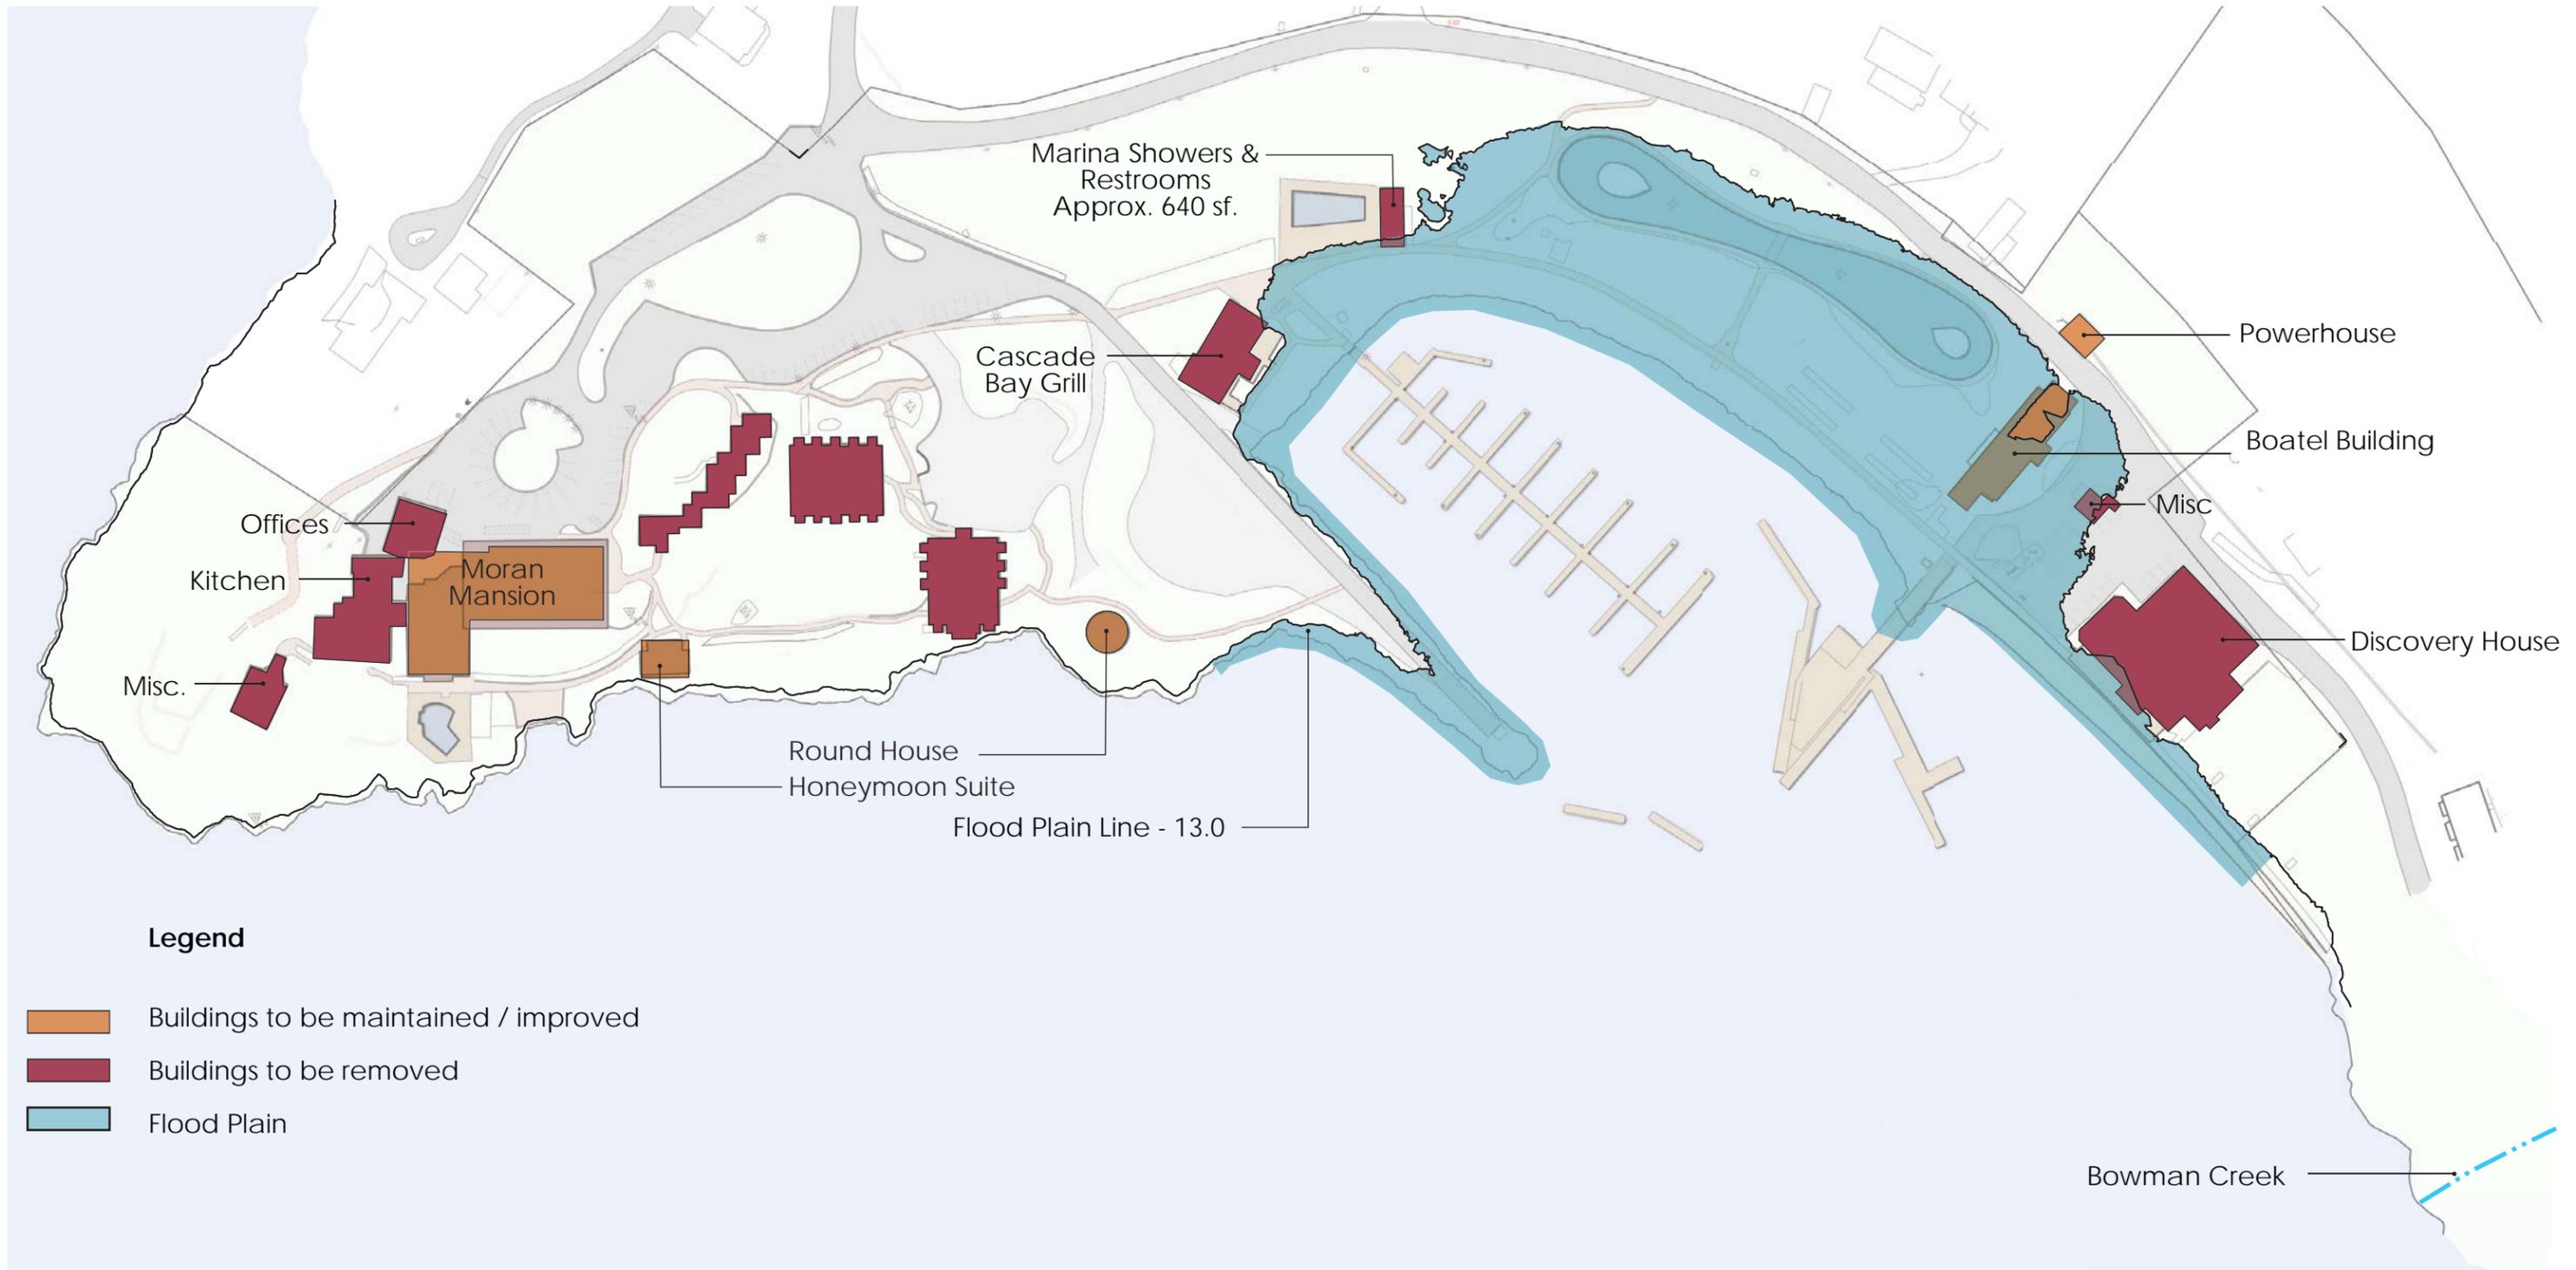
- Buildings to be maintained / improved
- Buildings to be removed
- Flood Plain

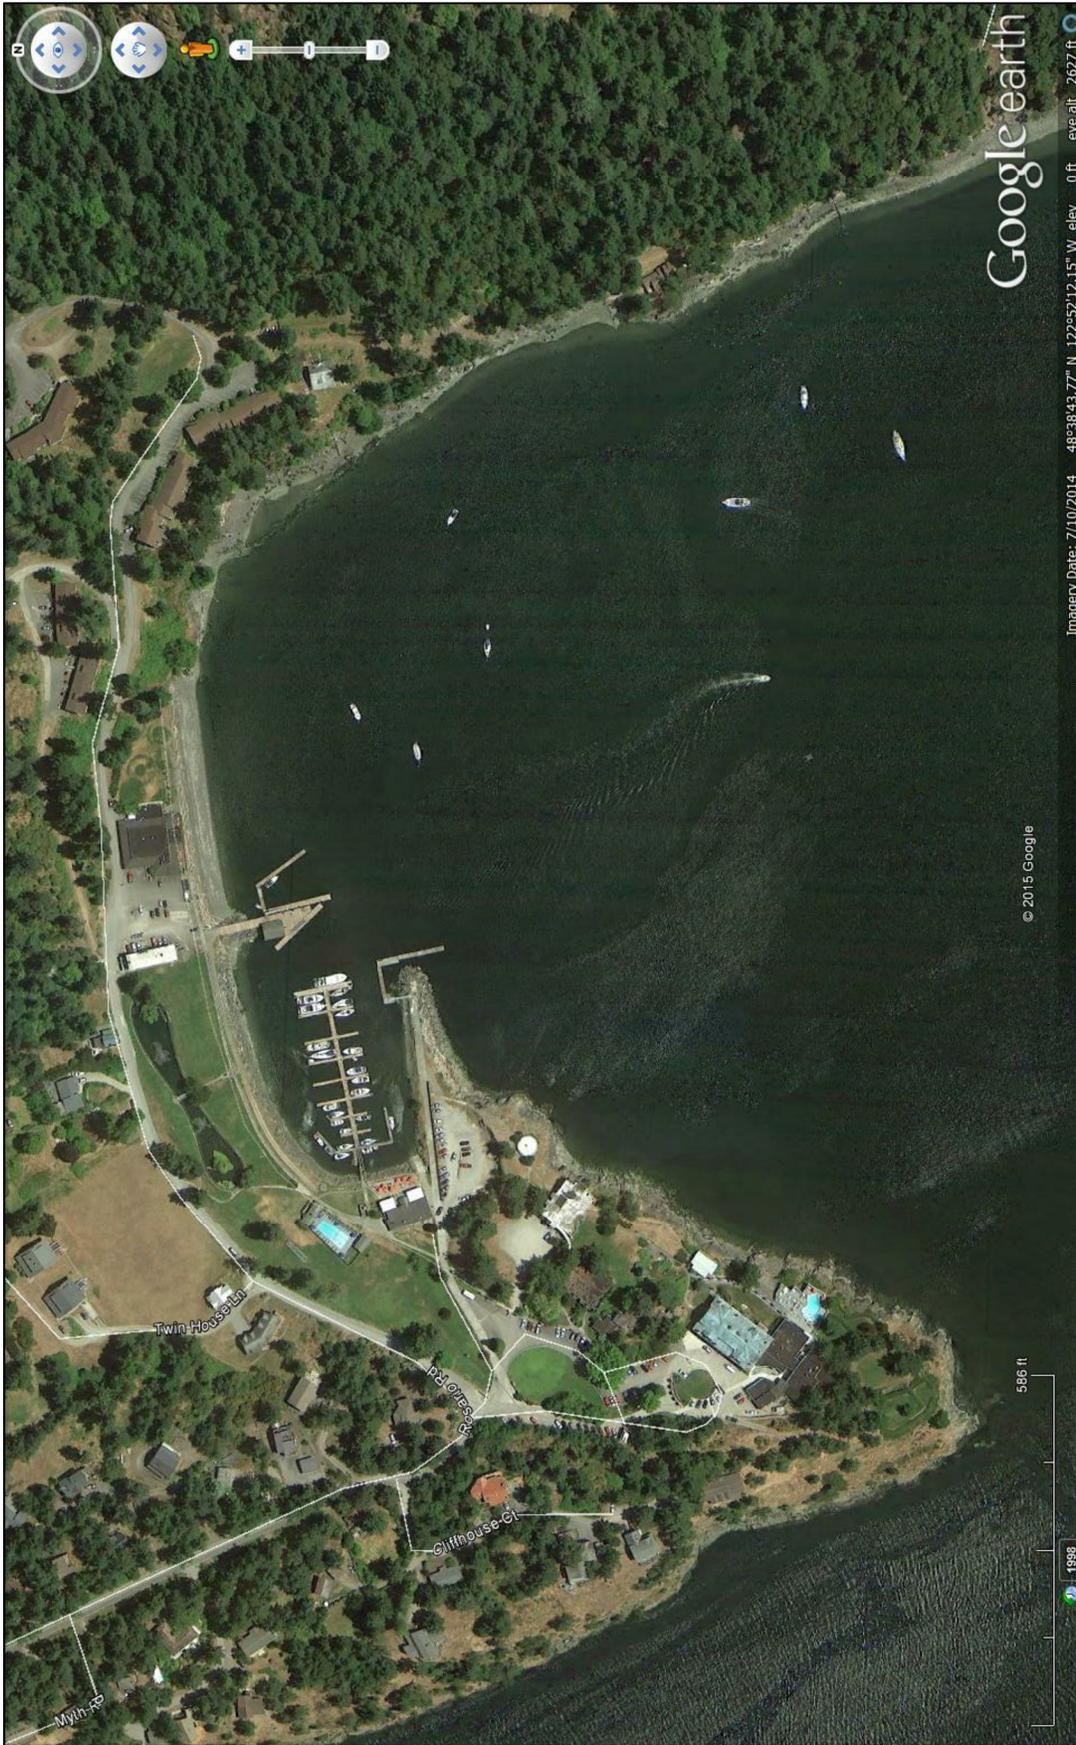
**Figure 2. Aerial Photograph Panned Out**

**Note** Baseaerial obtained from Google Earth.

The existing conditions of the overall development area include 10 buildings, six of which are in the uplands of the property and are used for guest accommodations. Along the shoreline, the Moran Mansion contains guestrooms, a historical museum, a year-round restaurant, a spa and fitness center, a gift boutique, and administrative offices. Nearby the mansion are the Mansion Pool, Honeymoon Suite, several guesthouses, and Activity Center. Also, adjacent to the shore is the historic Round House (used for accommodations), Boatel (used as storage), Powerhouse (contains Direct Current (DC) hydroelectric generator), a seasonal restaurant, a second in-ground pool, the Discovery House (used for conferences and large gatherings), and a man-made figure eight pond. There is a small marina with 34 slips on floating docks and a wooden pier; the structure is protected by a man-made jetty. The marina facilities are in poor condition and are in the process of being modified (Figures 2, 3 and 4).

The vegetated and faunal habitat within the 100 year floodplain is primarily mowed/maintained lawn (Figures 2 and 3). The area directly adjacent to the rip rapped shoreline is a gravel road and a paved sidewalk. The area directly adjacent to the concrete bulkhead is a paved sidewalk. There are three to four native conifer trees that have been historically maintained. There is neither native understory nor native herbaceous vegetation in this 100 year floodplain area. Faunal species are few to devoid except for an occasional deer and passerine birds.

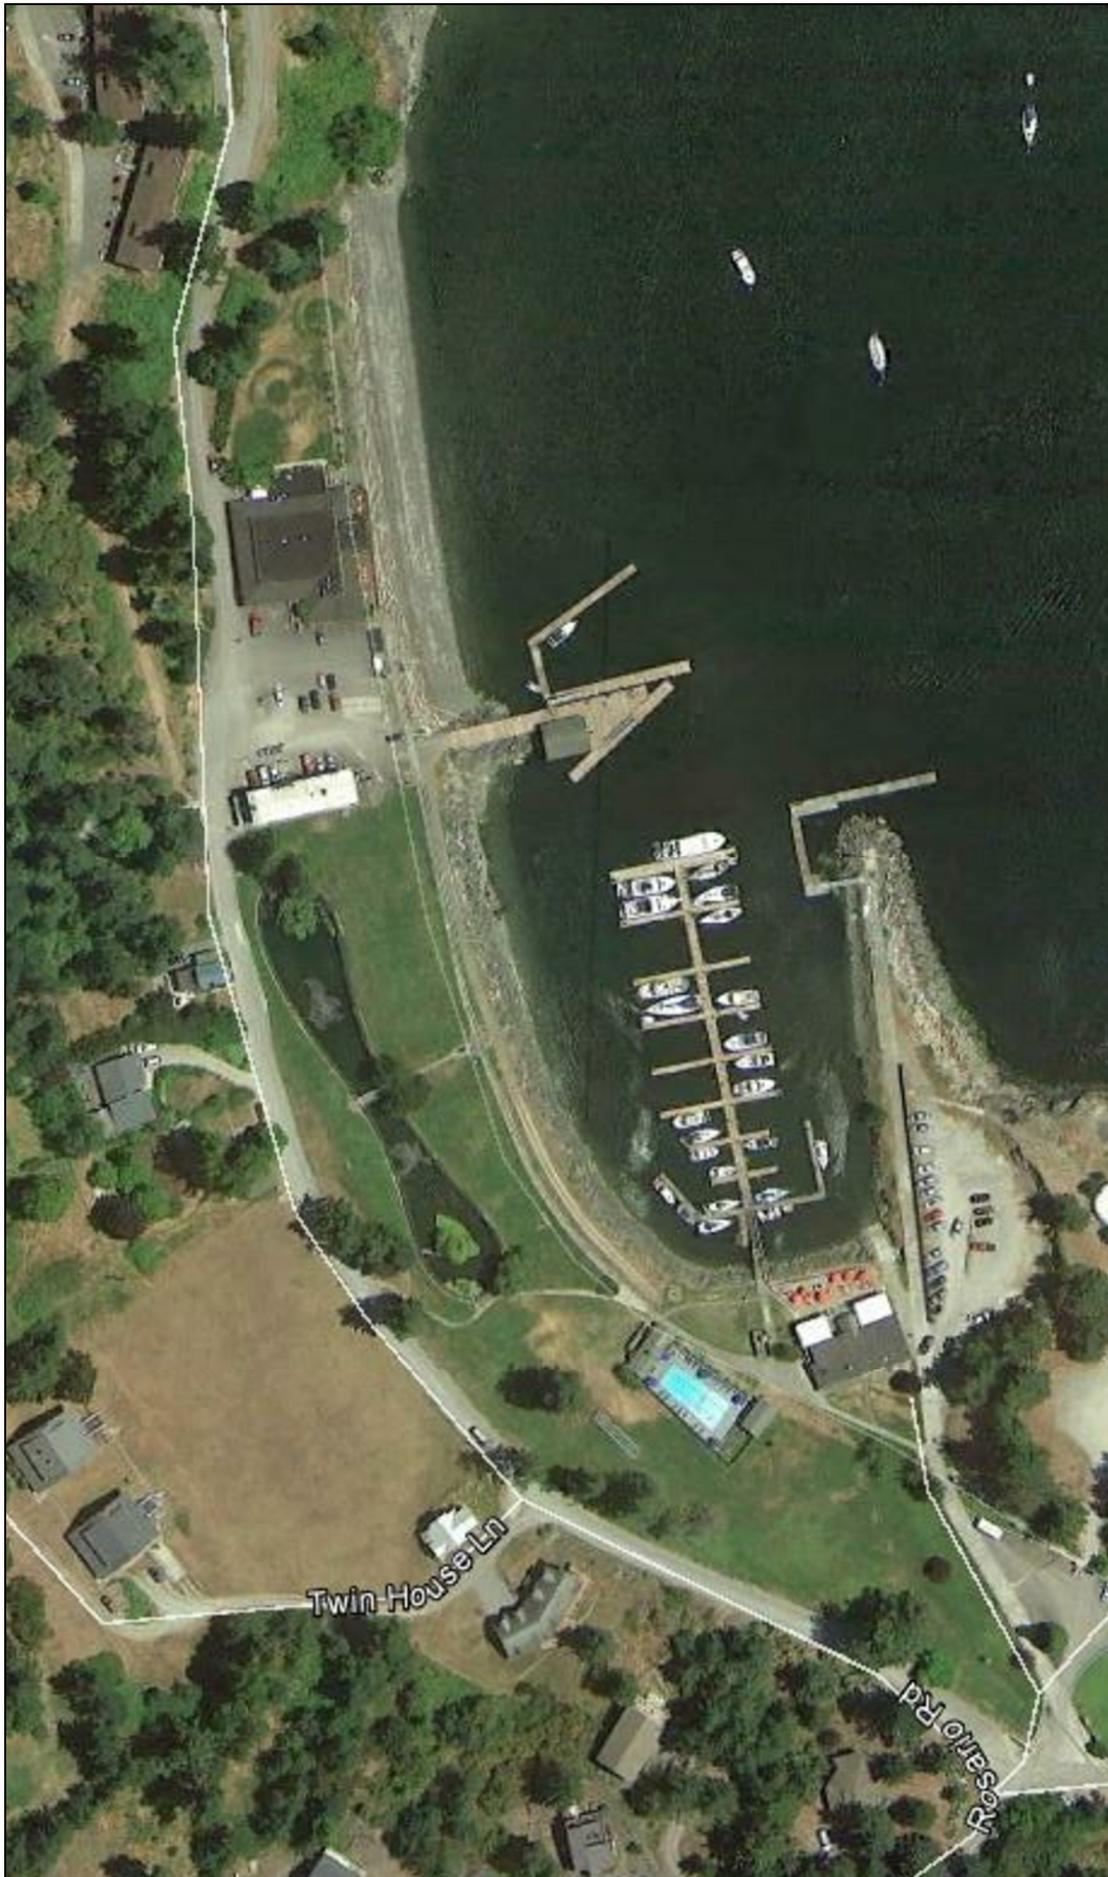
**Figure 3. Aerial Photograph Panned In**

**Note** Baseaerial obtained from Google Earth. Imagery date 10 July 2014.

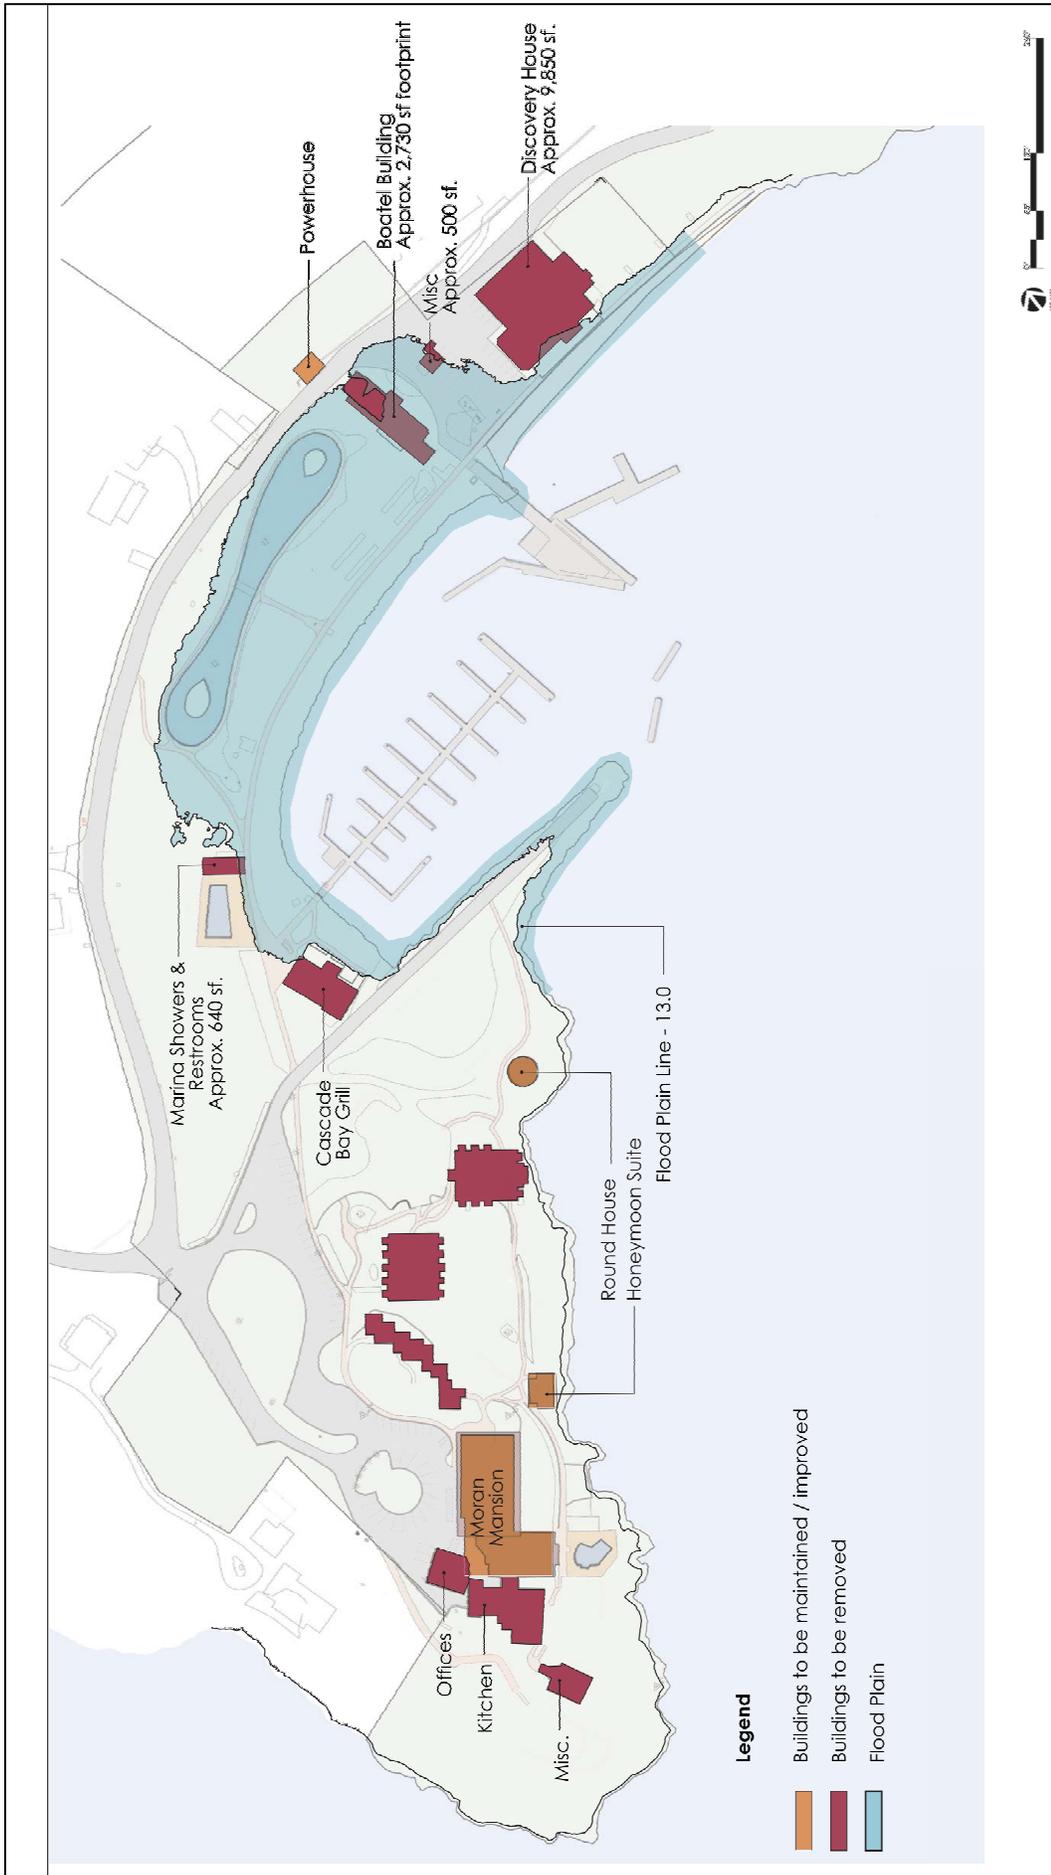
**Figure 4. Existing Conditions**

**Note** Basemap obtained from Rosario Resort PUD Application 28 January 2015.
